Memorandum

Subject: *Fred R. Rippy, Inc. – Indoor Air Vapor Intrusion/Conduit Assessment*

INTERIOR OFFICE & MANUFACTURING AREA REMODEL

FRED R. RIPPY, INC. WHITTIER, CALIFORNIA

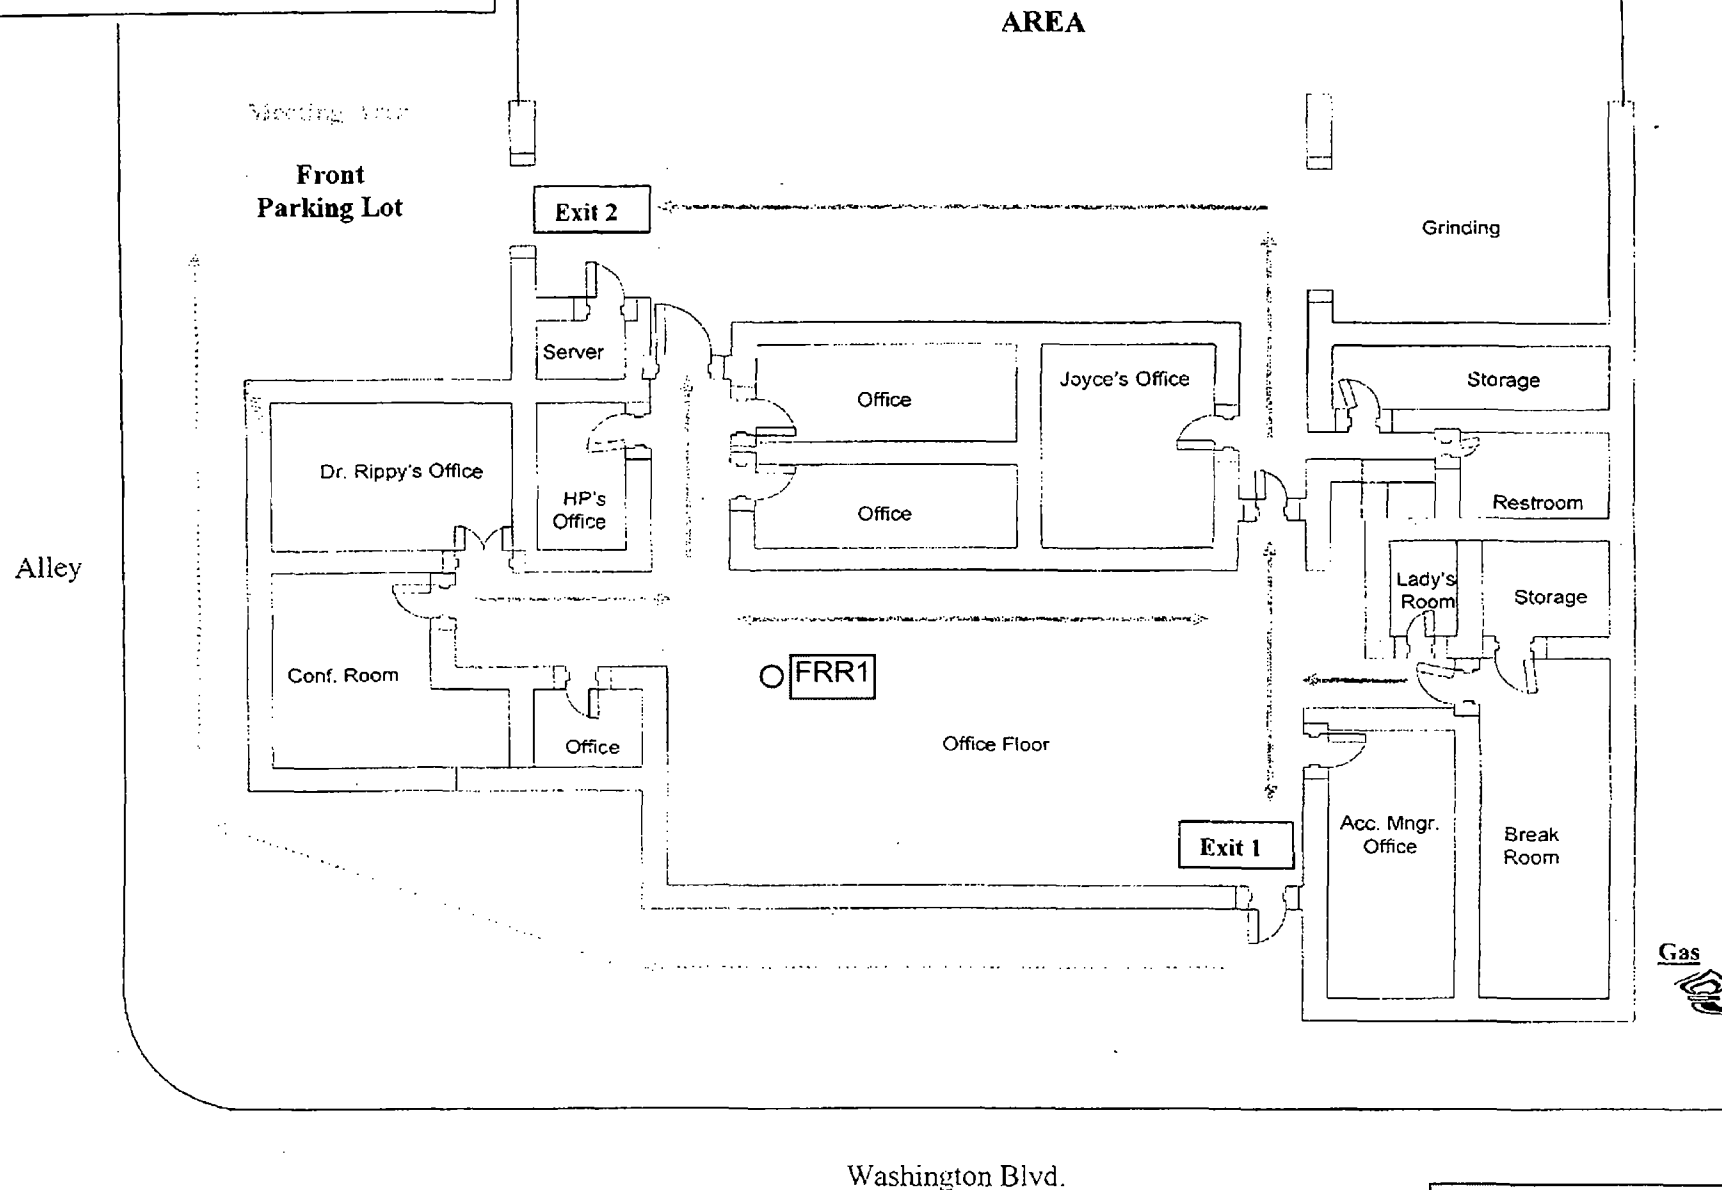
Figure 1 - Office Area

The front office area is located on the southern end of the one-story building (facing East Washington Blvd.) and contains a number of office rooms, storage rooms, and a break room. These locations are identified in Figure 1. These offices are typically occupied eight hours per day between five and six days a week. The storage areas primarily contain documents and files. The entire front office area was remodeled approximately one year ago.

Indoor air samples were collected from three locations at the FRR facility on July 1st (see attached Figures 1 through 3 for sampling locations). Samples were collected over an eight hour interval in 5 liter Summa canisters. The samples were analyzed for VOCs using method TO-15 SIM by Air Toxics, Ltd. During the July 1st sampling event, four samples were collected from the FRR property (one sample per area and one duplicate in the Office Area. The results were submitted to EPA in the Short Term Mitigation Air Sampling Report for June 2010 (CDM, July 28, 2010).

The "office floor" area illustrated in Figure 1 is furnished as a reception area and office space (Photo 1). Office cubicles are located along the north and south walls of the office floor. The floor is tiled with carpet in the areas occupied by the office cubicles. The tiling and carpet are in excellent condition (Photo 2) with only light scratches. No conduit penetrates the floor in this area.

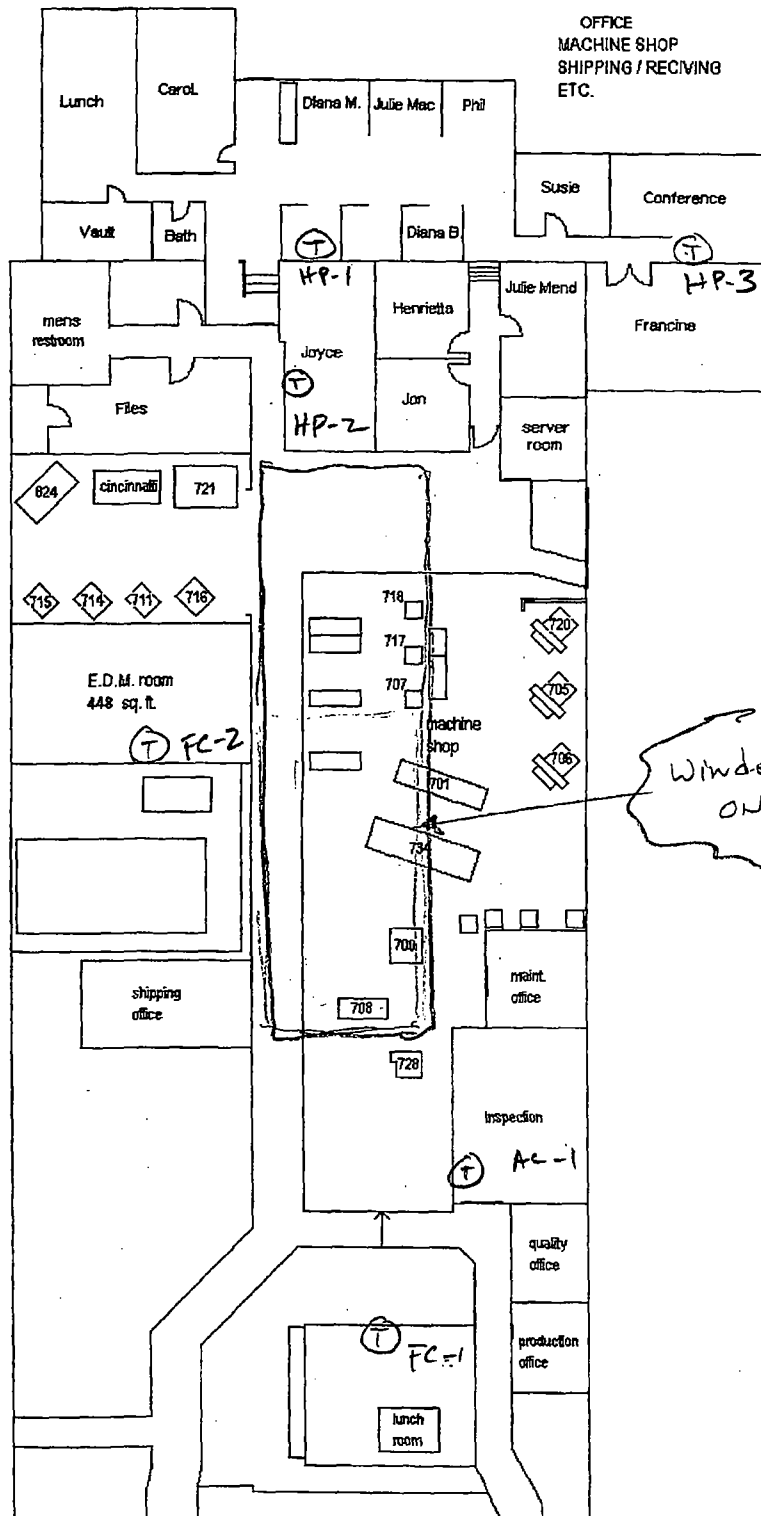
- This space is conditioned by one (1) York rooftop packaged heat pump unit (model B2HZ060A25) with manual outside-air damper (sizes and damper position as listed on attached report)

- This space is conditioned by one (1) York split system heat pump (fan-coil model EIRD036S25B). This system is not currently equipped with a means of outside air.

- This space is conditioned by one (1) York rooftop packaged heat pump unit with manual outside-air damper (sizes and damper position as listed on attached report).

- This space is conditioned by one (1) Carrier split system air conditioner (fan-coil model 48SS02404021). This system is not currently equipped with a means of outside air.

- This space is conditioned by one (1) Carrier split system air conditioner (fan-coil model 25HCA324A300). This system is not currently equipped with a means of outside air.

- This space is conditioned by one (1) Carrier split system air conditioner (fan-coil model FB4ANF060). This system is not currently equipped with a means of outside air.

It is our recommendation that the existing mechanical equipment should be retrofitted with a means of outside air to provide code-minimum ventilation to the occupied space.
